INTERSTATE COMMERCE COMMISSION
WASHINGTON

REPORT OF THE DIRECTOR
BUREAU OF SAFETY

ACCIDENT ON THE
CHICAGO, ROCK ISLAND & PACIFIC RAILWAY

INVESTIGATION NO. 2202

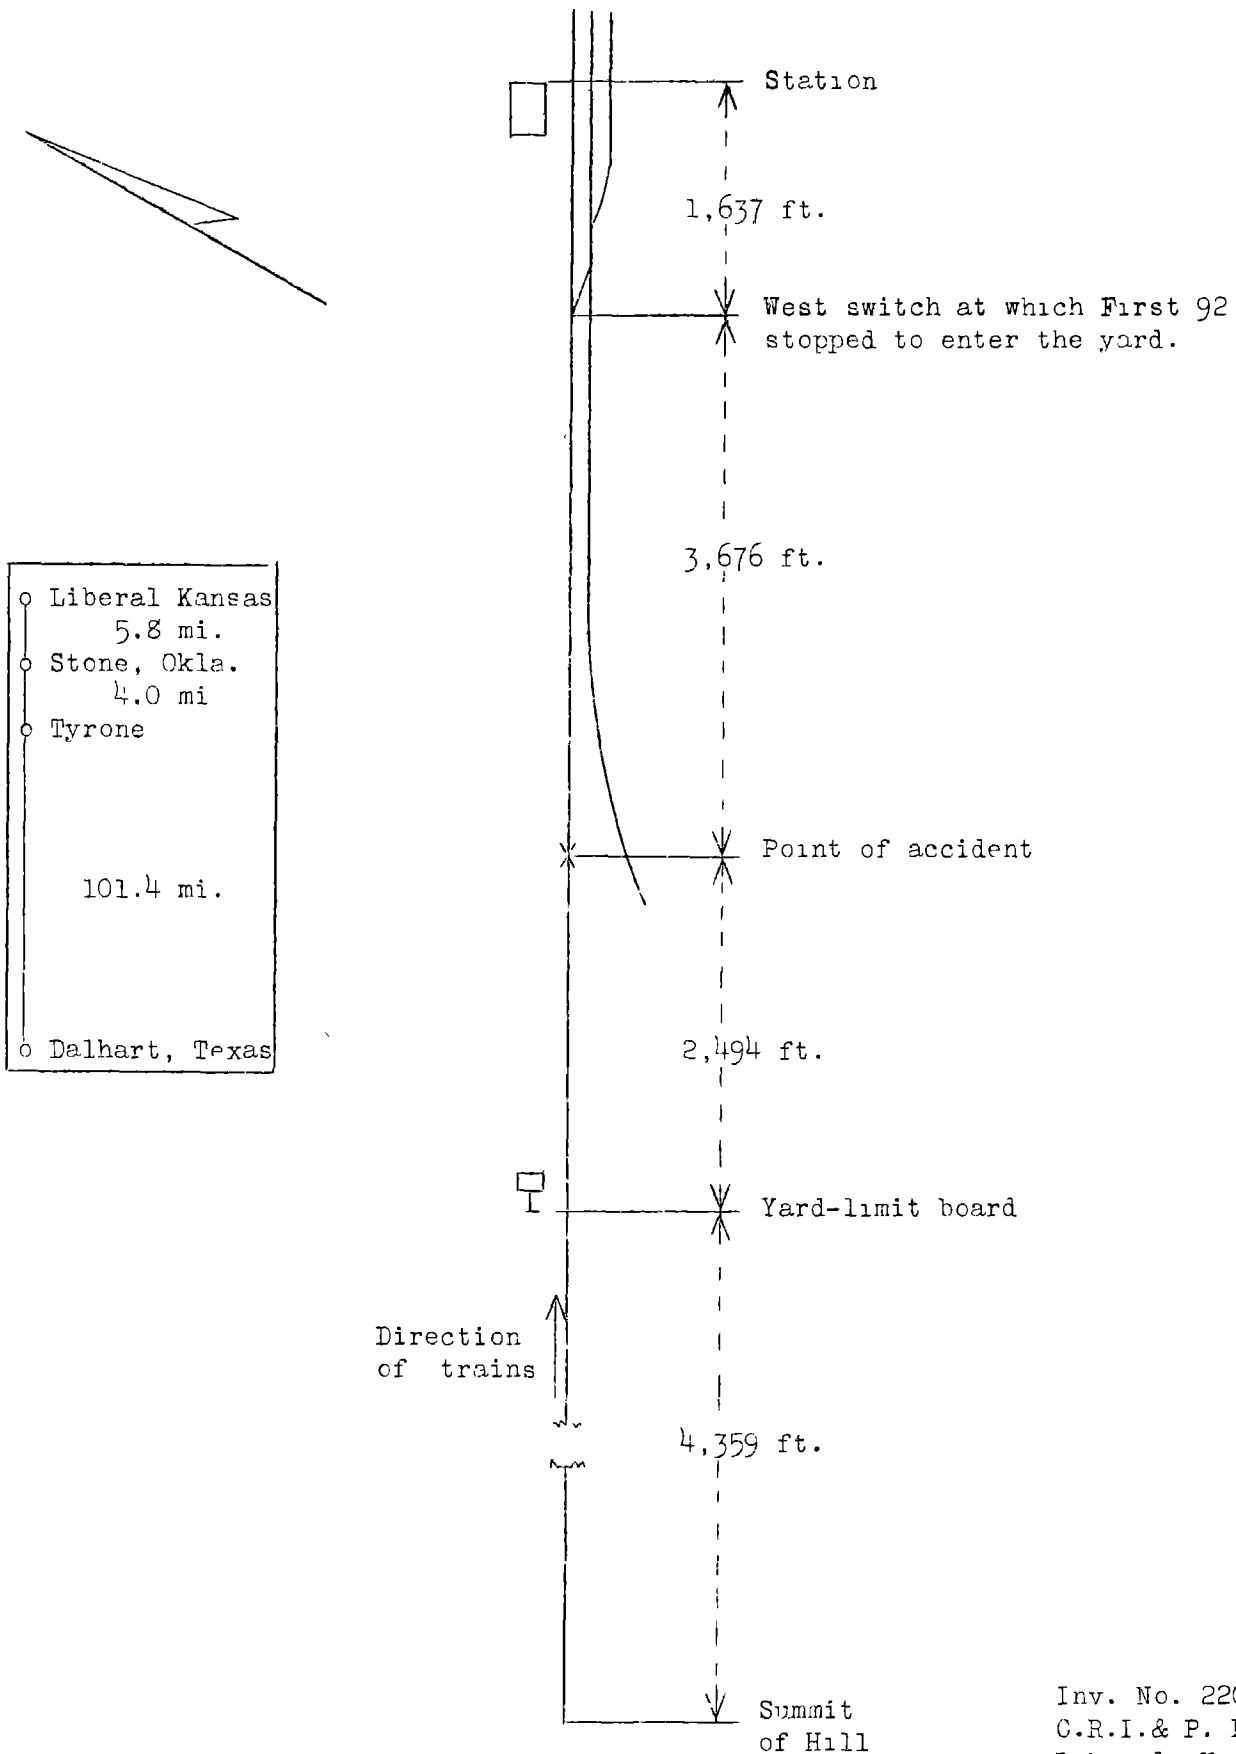
Inv. No. 2202
C.R.I. & P. Ry
Liberal, Kans
Oct. 2, 1937

The engine of Second 92 telescoped the caboose of First 92, demolishing it and causing slight damage to the car ahead of it. The caboose was derailed and the flange of one wheel of the rear truck of the rear car was on the ball of the rail. Engine 5030 sustained only slight damage; the engine truck wheels were raised about 8 inches above the rail and the flanges of the driving wheels on the left side were on the ball of the rail. The stock caretakers injured were in the caboose of First 92.
